# Weekly Engineering Action Report

# Northlake Medical Office Building

SITE Northlake Medical Campus

Sep 21–27, 2026

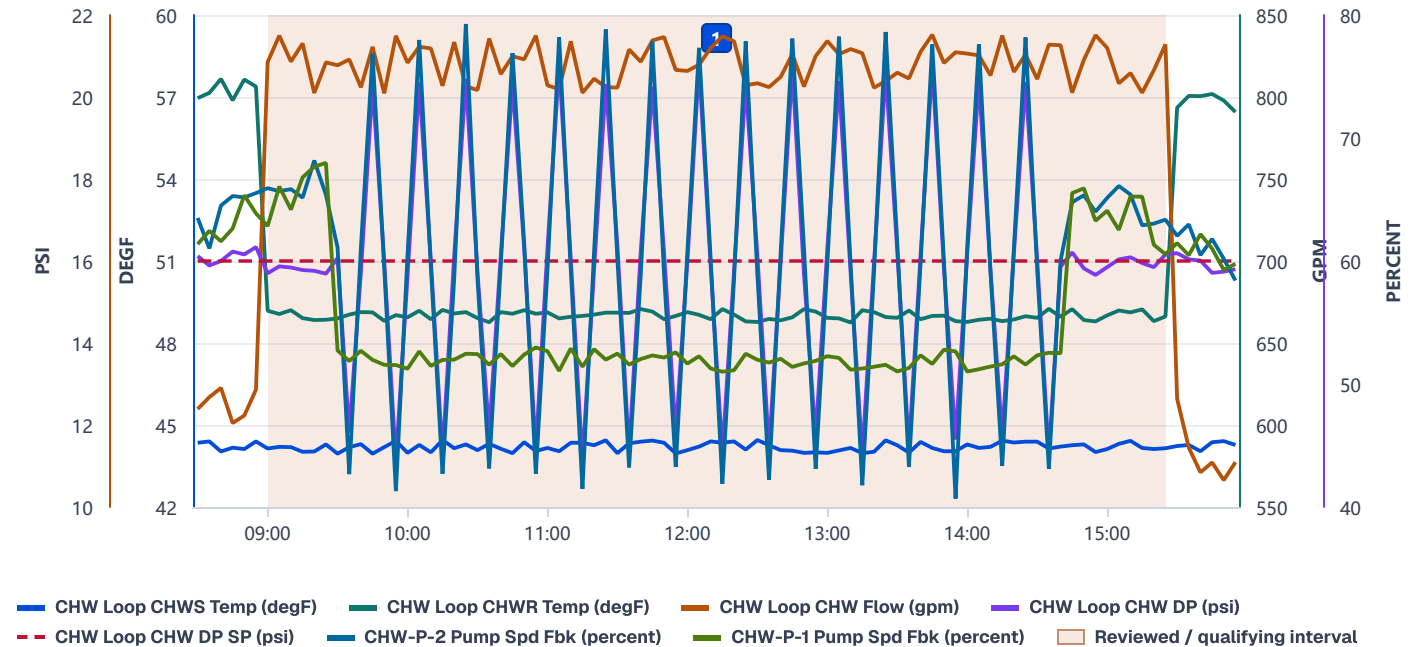
Measurement accuracy and a common loop measurement boundary are unverified. Required flow, expected delta-T, thermal load, and operating mode are not established. Pressure and separate pump-speed response patterns do not establish the cause. These limits prevent confirmation of excess circulation for the load. Energy use, cost, and effects on served conditions are not quantified.

- Chilled-water flow remained high while the return-to-supply temperature difference stayed low, an excess-circulation and plant-efficiency signature.  
 Low chilled-water delta-T while loop flow remained elevated 385 min

| RECOMMENDED FIELD ACTION<br>Validate the CHW Loop temperature and flow measurements first. Confirm the measurement boundary and documented operating targets. If the pattern persists, compare loop differential pressure and its setpoint with separate speed feedback from CHW-P-1 and CHW-P-2 before adjusting controls. Compare supply temperature with its setpoint during the low delta-T condition. | | | | | | | | |

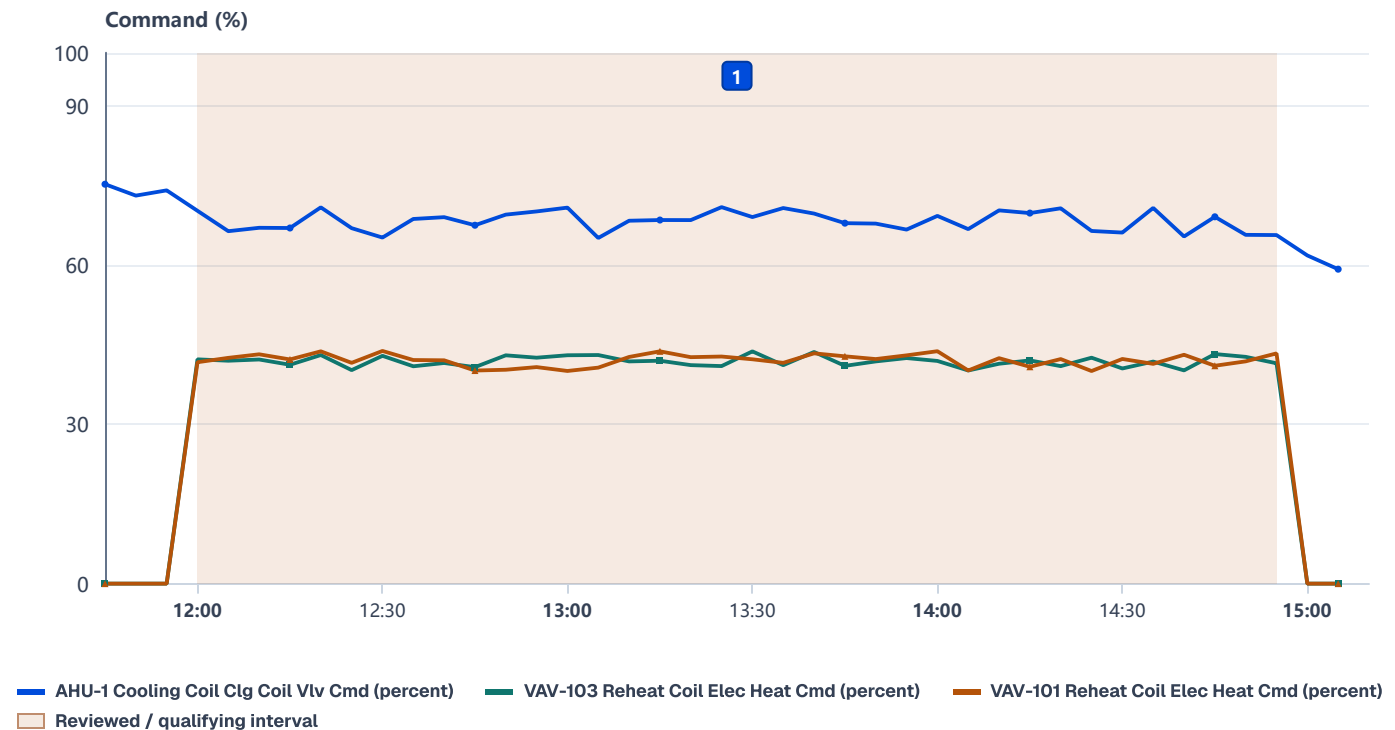
AHU-1 cooling commands overlapped downstream electric reheat commands. Actual heating and cooling remain unconfirmed, and zone demand or intended sequence exceptions may justify the overlap.

- AHU cooling command was active while one or more downstream VAV reheat commands were elevated.  
 VAV-103 Reheat Coil Heating Coil Electric Heat Command reheat active while AHU cooling active 175 min

- Mechanical:** Compare VAV-101 and VAV-103 electric reheat commands with heater current and measured air temperature rise.
- Mechanical:** Compare AHU-1 cooling valve command with valve travel and measured air temperature across the cooling coil.
- Controls:** Compare AHU-1 discharge air temperature with its setpoint while cooling and reheat commands overlap.
- Controls:** Trace VAV-101 and VAV-103 reheat requests to their demand logic, overrides, and approved sequence.
- Validation:** Measure corresponding zone conditions during reheat command overlap to confirm whether demand justifies it.

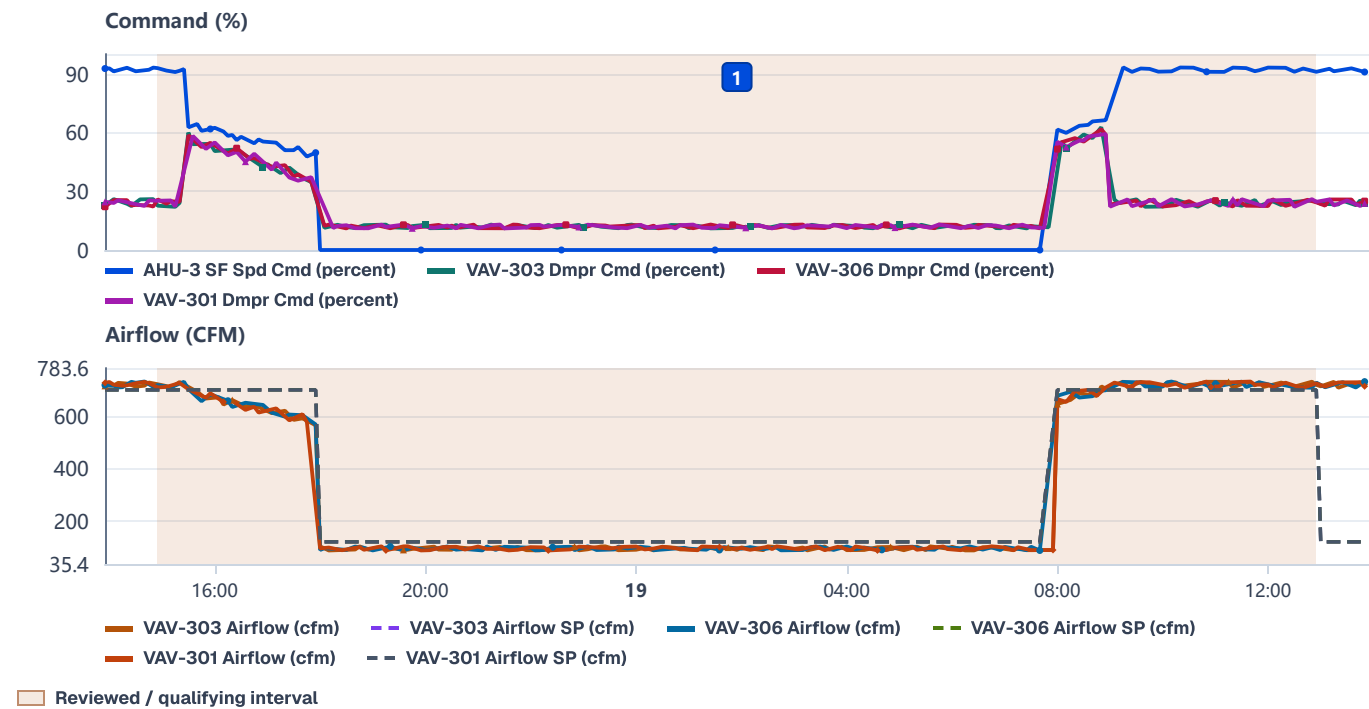
- AHU-3 fan speed command averaged 92% while terminal damper commands averaged 24%, supporting a controls investigation rather than a confirmed pressure-reset fault. A subsequent staff-transcribed synthetic field report documented a split pressure pickup tube and leaking fitting. The tube was replaced and fittings secured. Mountvera-reviewed trends supported improvement, but did not prove repair causality.  
 Selected evidence context

Confirm command against measured fan speed during comparable low terminal demand. If they agree, trace the command source, limits, overrides and terminal-demand reset logic. Use the completed pressure pickup repair and spot validation as the baseline for remaining pressure checks where available. Confirm Occupied Mode and approved ventilation requirements before testing a lower command. Resolve remaining terminal damper and airflow discrepancies with mechanical/TAB checks. Continue monitoring under comparable operating conditions to confirm the result is sustained.

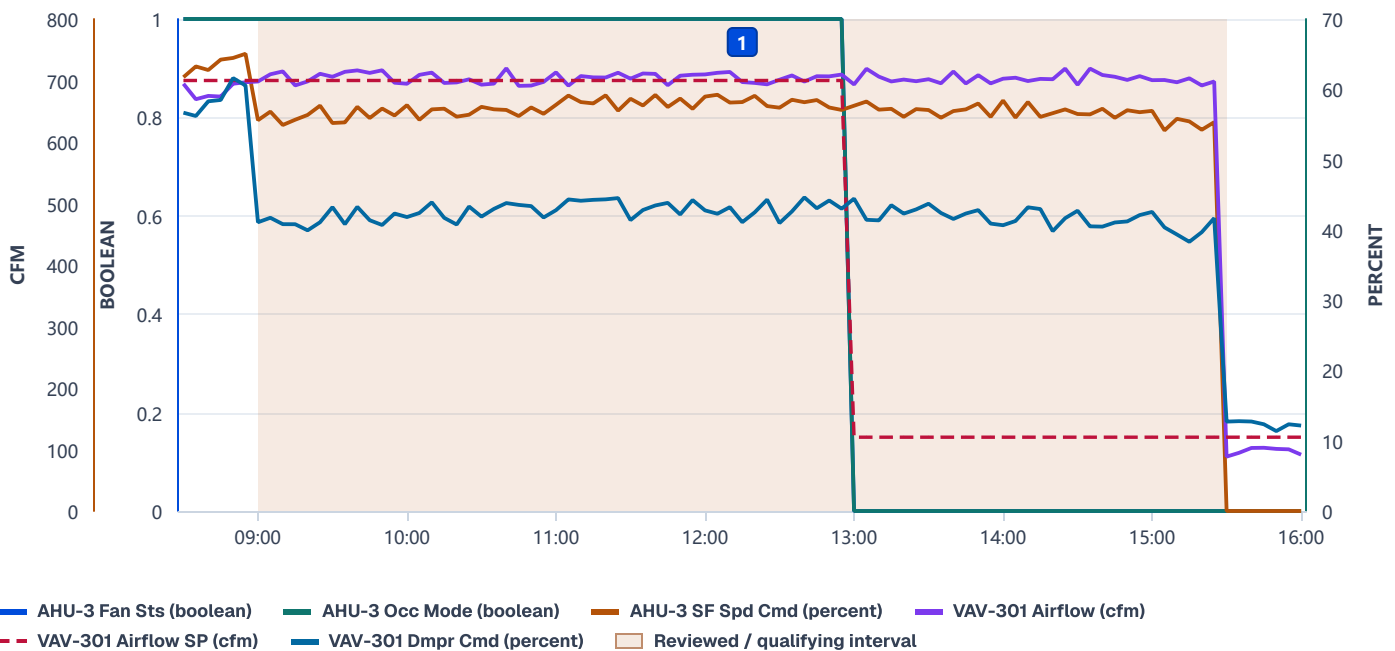
- 1 Reviewed post-action comparison signals. Occupied mode and fan status identify operating context; this chart does not independently establish repair causality.

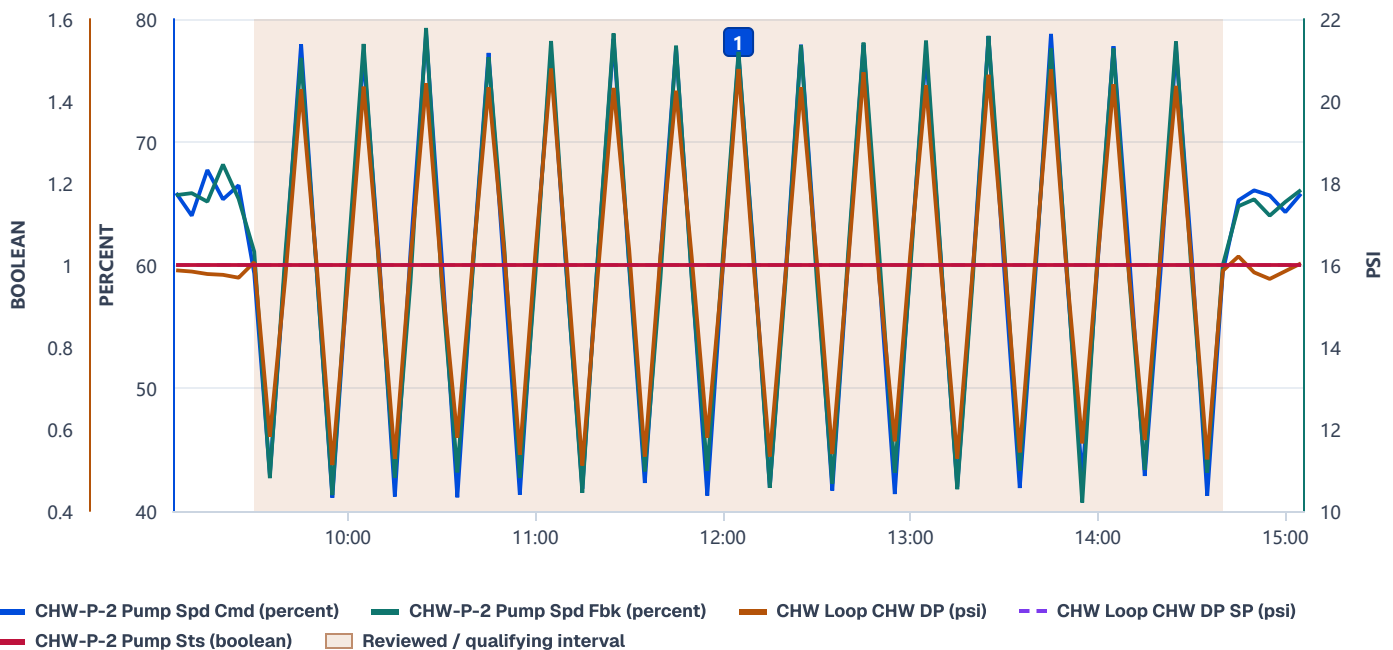
- DP-control tuning or response that sustains speed cycling:** The speed command cycles with loop DP error, and feedback closely follows the command. This relationship could reflect a control response that sustains cycling.
- Changing hydraulic demand or interaction between pump controls:** Changes in shared loop DP could drive repeated speed-command adjustments. Hydraulic demand or interaction with CHW-P-1 controls could contribute.
- DP setpoint changes that provoke repeated speed adjustments:** The shared loop setpoint varied during the observed pattern. Setpoint changes could drive speed adjustments rather than tuning-related cycling.
- Loop DP measurement instability or scaling discrepancy:** An unstable or incorrectly scaled DP reading could provoke command cycling that speed feedback follows.

Local speed response and DP measurement accuracy remain unverified. Control tuning, response timing, setpoint-reset logic and changing hydraulic demand are not established, so the initiating cause cannot yet be distinguished. The reviewed data did not establish CHW-P-1 behavior or pump-control interaction. Reduced cooling service, energy waste and equipment damage are not established.

- The selected pump's command and feedback varied with shared loop differential pressure and setpoint within this contiguous operating interval. The interval bounds an observed cycling pattern, not proof of uninterrupted hunting at every sample.

CHW-P-2 Pump Speed Command speed hunting while loop DP varied 310 min

| RECOMMENDED FIELD ACTION<br>Validate local speed response and the loop DP signal before changing tuning. If both agree with BAS, use synchronized trends to distinguish control response from setpoint changes, hydraulic demand and pump-control interaction. Correct only the cause supported by those checks. | | | | | | | | | | |

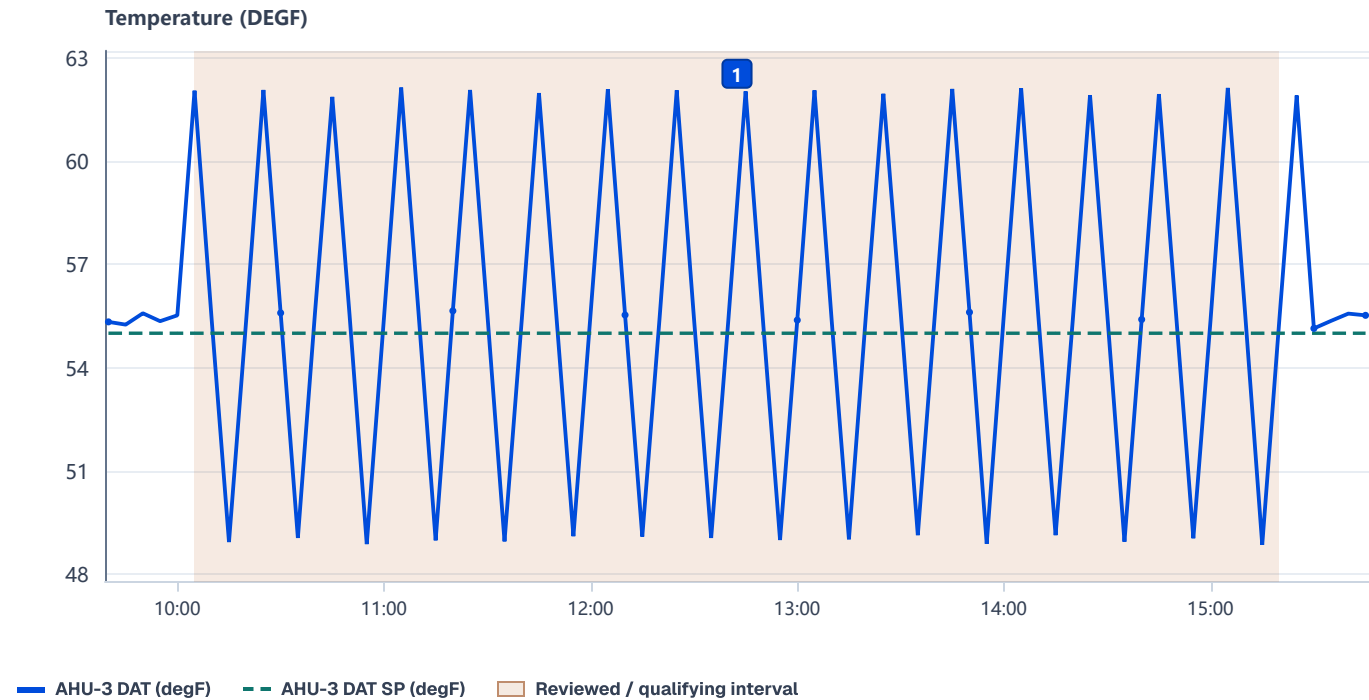
AHU-3 discharge air temperature departed from its measured setpoint in both directions. Each evidence window reports a representative temperature of 62.1 °F against 55.0 °F, with signed deviation extrema of -6.1 °F and 7.1 °F. These measurements do not establish a continuous warm-air condition. The evidence windows span 815 minutes and contain 415 cumulative minutes of the observed condition. This does not establish uninterrupted operation.

Sensor accuracy and location, loop output, active setpoint handling, occupied mode, and actual fan operation remain unverified. The reviewed data did not establish conditioning output or the physical cause of the departures. These limits prevent a cooling-only diagnosis. Occupied-space and energy impacts are not established.

- Discharge air temperature stayed away from setpoint beyond the configured deadband.  
Cumulative deviation 160 min

| <b>RECOMMENDED FIELD ACTION</b><br>Validate the discharge air temperature measurement first. Then confirm fan operation, occupied mode, and the active setpoint during comparable departures. Use the confirmed temperature response to decide whether control-loop investigation or further delivered-air testing is needed. | | | | | | | |

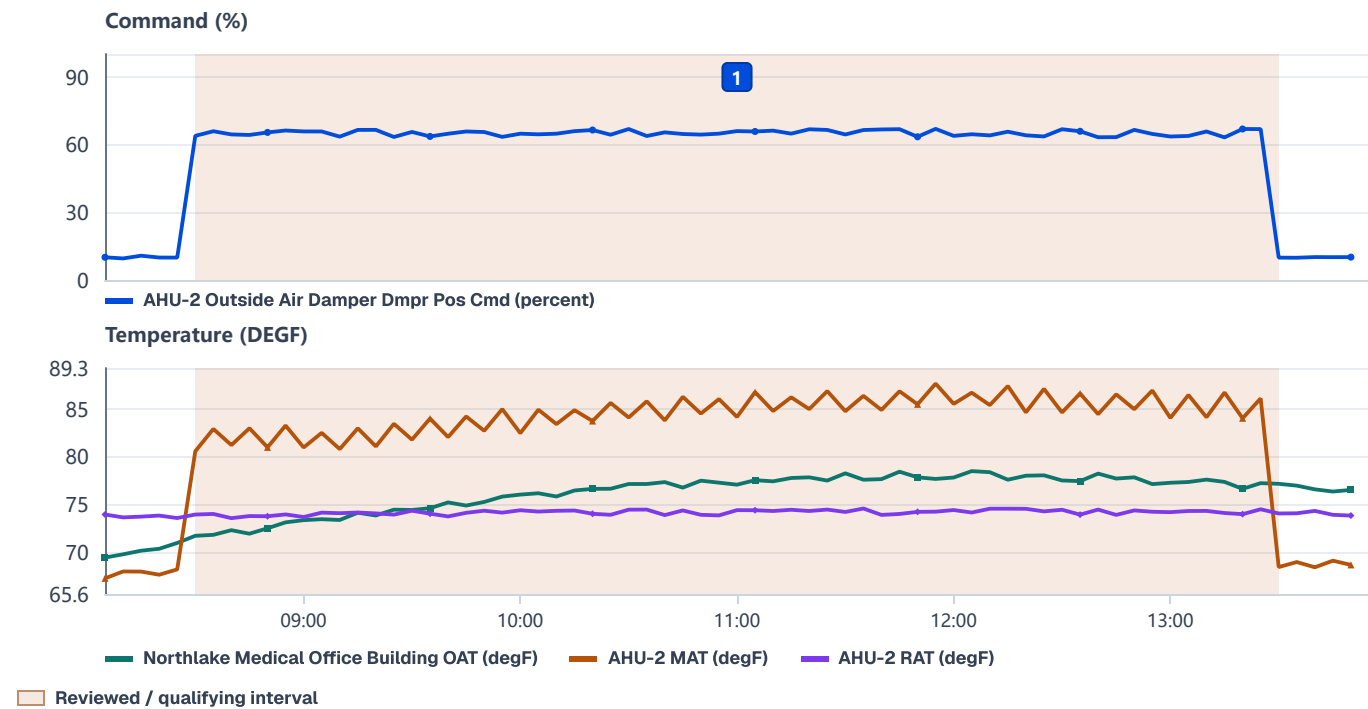
- AHU-2 mixed-air readings were above both source-air readings, with representative values of 87.3°F and 87.6°F during outside-air damper commands. The baseline investigation favored validating the measurement before assigning a damper fault. Subsequent staff-transcribed demonstration findings reported a cabinet-temperature source mapped to the BAS mixed-air input and correction to the existing mixed-air probe. MAT outside OAT/RAT bounds

Resolve the remaining low mixed-air discrepancy by validating the existing probe reading and BAS input source against a calibrated air traverse during comparable damper commands. Confirm source-air sensor accuracy, representativeness and measurement consistency before changing controls or replacing components. Compare command with observed blade position during that validation, recognizing that reported travel testing is already complete.

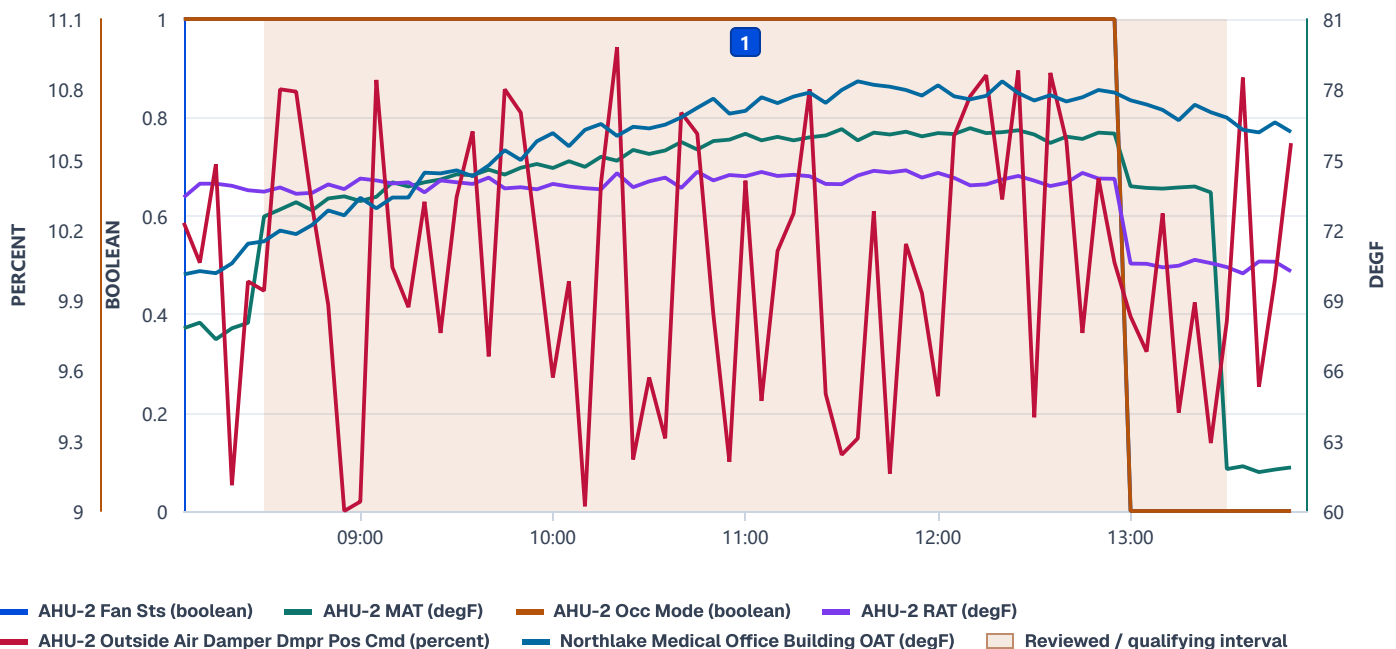
- Reviewed post-action comparison signals. Occupied mode and fan status identify operating context; this chart does not independently establish repair causality.  
Selected evidence context

Continue monitoring under comparable operating conditions to confirm the result is sustained.

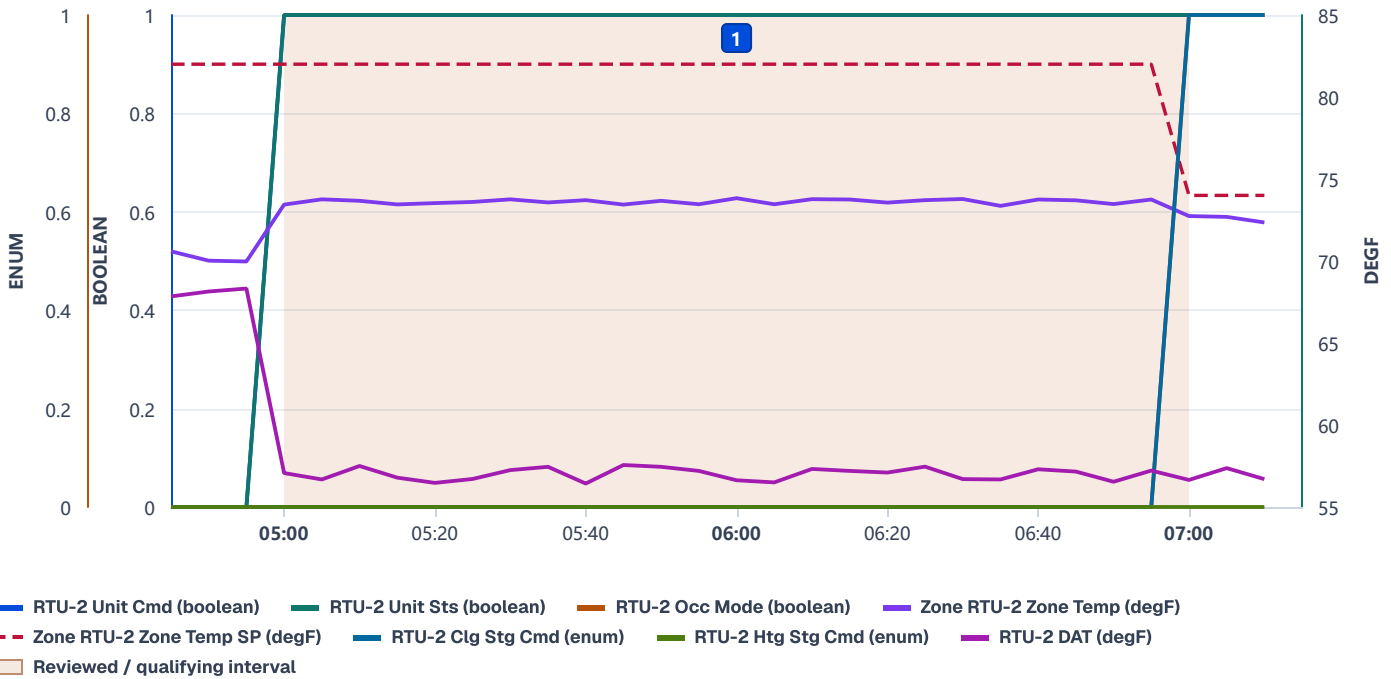
RTU-2 showed preoccupancy runtime without active heating or cooling stage commands in synthetic demonstration evidence. Unit command and proof were active while Occupied Mode indicated unoccupied operation. This supports checking the early enable, but does not establish unnecessary runtime or a mechanical cause.

The reviewed data did not establish field operation, intended schedule timing, optimal-start configuration, recovery demand, override state, or command source. Actual heating and cooling operation remains unconfirmed. These gaps prevent determining whether the early enable is necessary or identifying a mechanical cause. Energy use and comfort impact are not quantified.

- The RTU was enabled and proven running before occupancy while cooling and heating stages were inactive.  
unit running before occupancy without staged demand 120 min

- Controls: Trace RTU-2's preoccupancy unit command. Compare its source and timing with the intended schedule and start logic.
- Controls: Check RTU-2 for active overrides or retained enables while Occupied Mode indicates unoccupied operation.
- Mechanical: Validate the synthetic operating pattern by comparing RTU-2 Unit Command and Unit Status with observed preoccupancy operation before changes.
- Controls: Compare heating and cooling stage commands with actual stage operation during the early unit enable.
- Controls: Adjust the schedule, override, or start logic only after field validation and only if the early enable is not required.

| <b>RECOMMENDED FIELD ACTION</b><br>Validate the synthetic operating pattern against field operation before making changes. Identify the source and intended timing of RTU-2's preoccupancy unit command. Adjust the schedule, override, or start logic only if the early enable is not required. | | | | | | | |

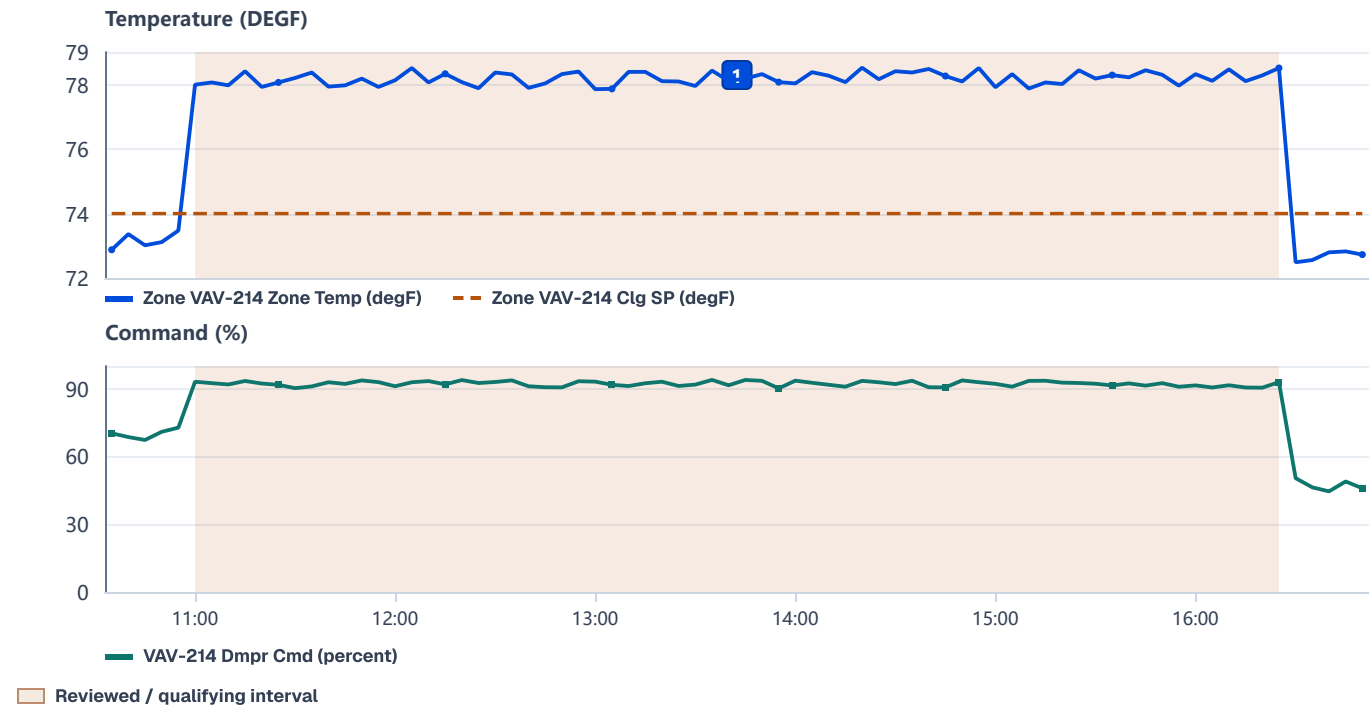
Synthetic data shows VAV-214 at a high damper command while its served zone remained above the measured cooling target. Damper command averaged 92%, and zone temperature was 3.9 to 4.6°F above setpoint. This demonstrates an operating pattern, not a confirmed field condition.

The high command indicates cooling control intent without the expected zone temperature recovery. This relationship is consistent with insufficient delivered cooling or a sensor or active-target discrepancy. Command alone does not establish blade position or airflow. If both respond as expected, discharge-air conditions could explain the warm zone.

- Airflow delivery limitation despite high damper command:** High damper command with a warm served zone could reflect limited delivered airflow. The reviewed data did not establish airflow or its relationship to the airflow setpoint.
- Damper command-to-position response mismatch:** Actuator or linkage response could prevent actual blade position from following the high command. Command alone does not confirm physical damper operation.
- Insufficient discharge-air cooling during high damper command:** If blade position and airflow respond to command, discharge-air conditions could explain the warm zone. Discharge-air temperature needs field validation.
- Zone temperature bias or active-target mismatch:** Sensor bias or unresolved active-target context could explain the measured temperature deviation and high command. Sensor accuracy, operating mode and occupancy remain unverified.

- 1 Damper command was high while zone temperature remained above cooling target.  
damper full open while zone above cooling target 325 min
